CONSERVATION TREATMENT REPORT

Altar Ceiling Painting
St. Mary's Catholic Church
95 Hasell Street
Charleston, South Carolina 29401

Submitted by:
Catherine Rogers

February 5, 2023

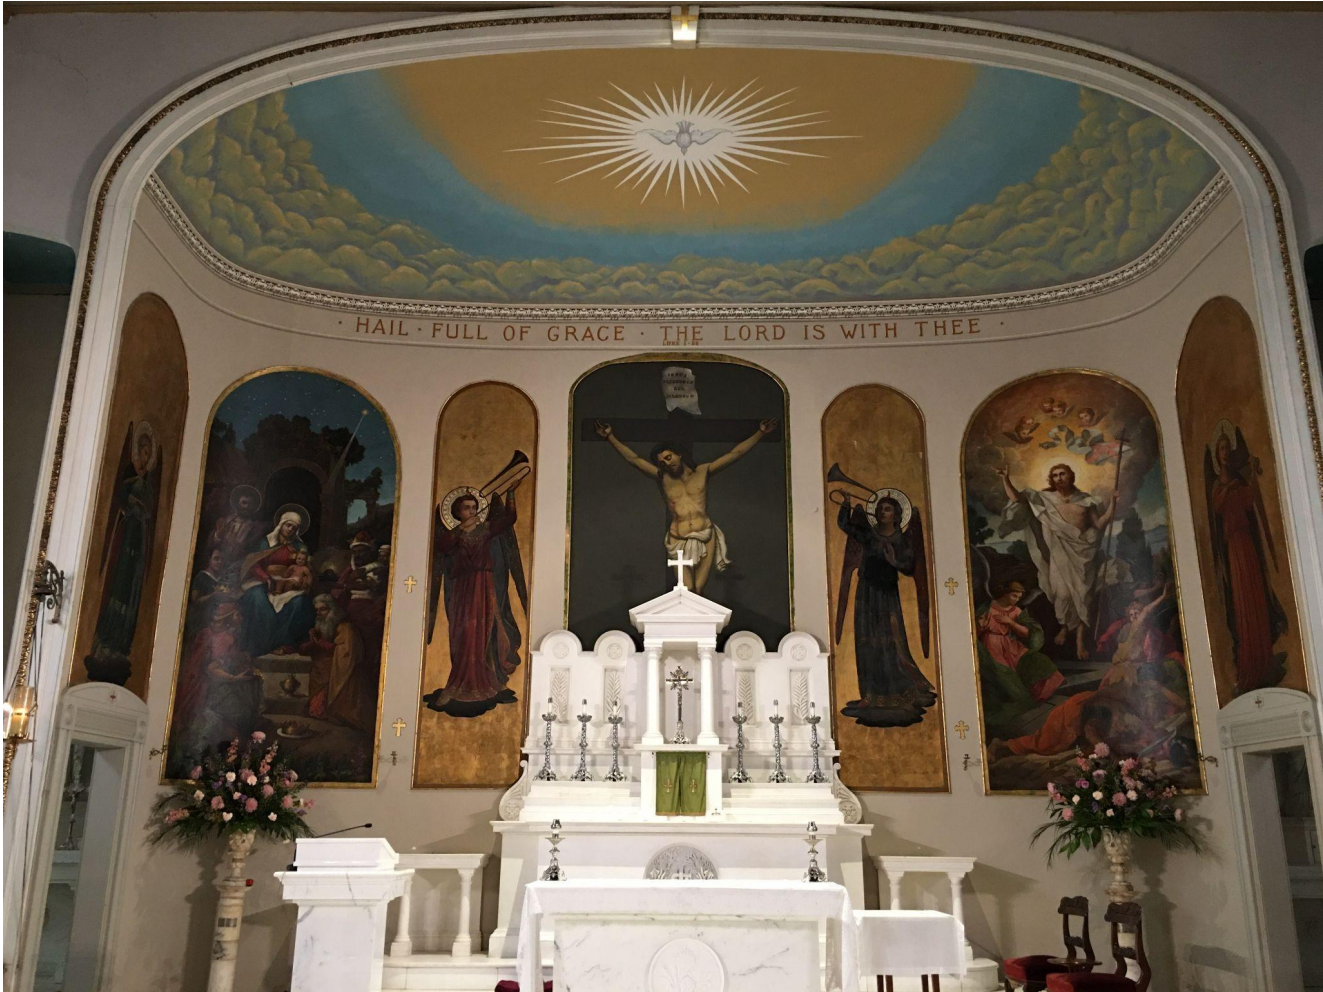
Before Treatment

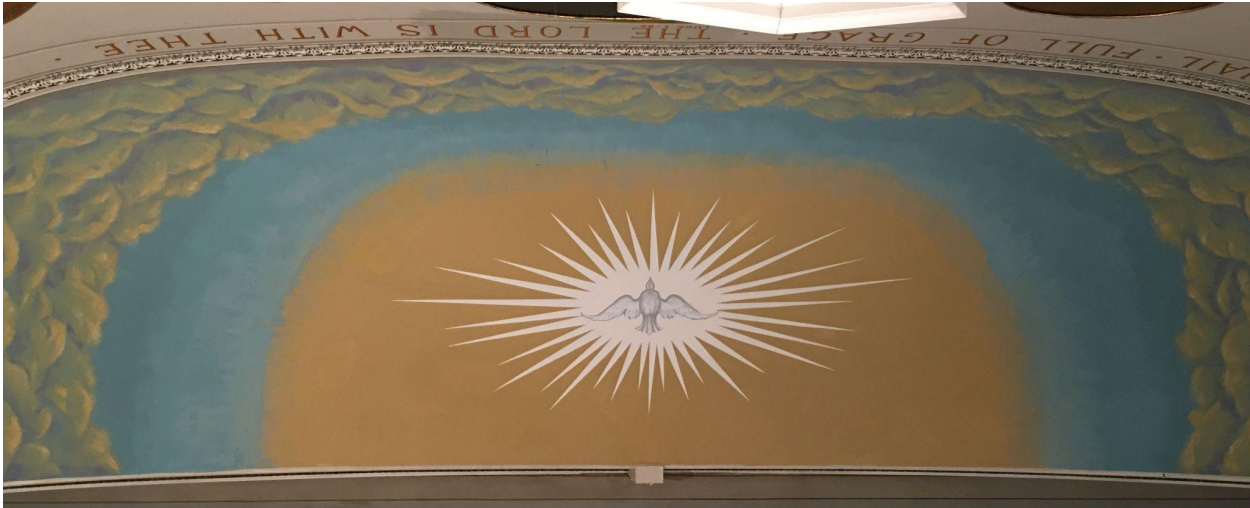
Before Treatment

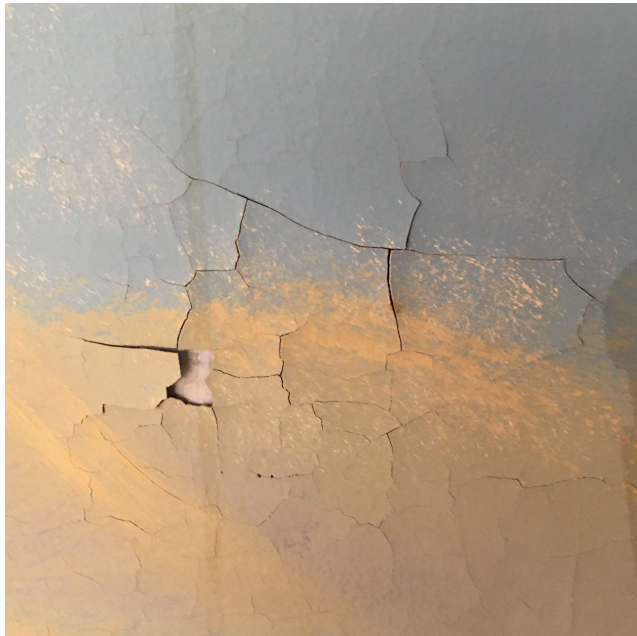
Detail of Lifting and Flaking Paint

The numerous areas of scattered flaking paint on the surface of the altar ceiling were removed mechanically by scraping and sanding. Areas of paint loss were filled with a reversible vinyl fill

material and any excess was cleaned using a damp sponge. All areas of present lifting and flaking in the paint layer were addressed but ongoing monitoring of the altar ceiling painting is recommended in case further lifting and flaking become an issue.

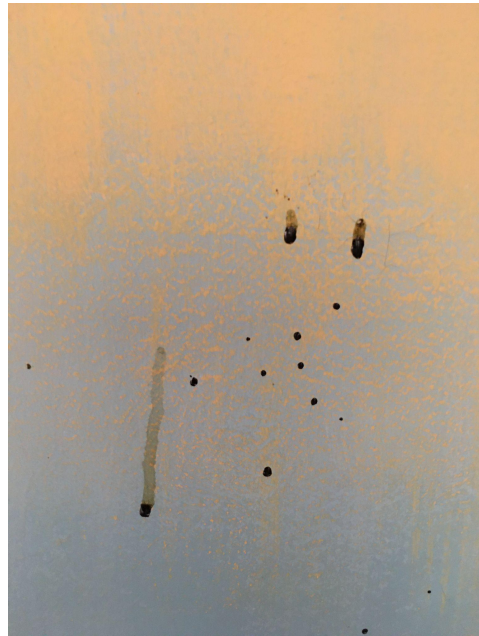
Detail of Drips on Ceiling Painting

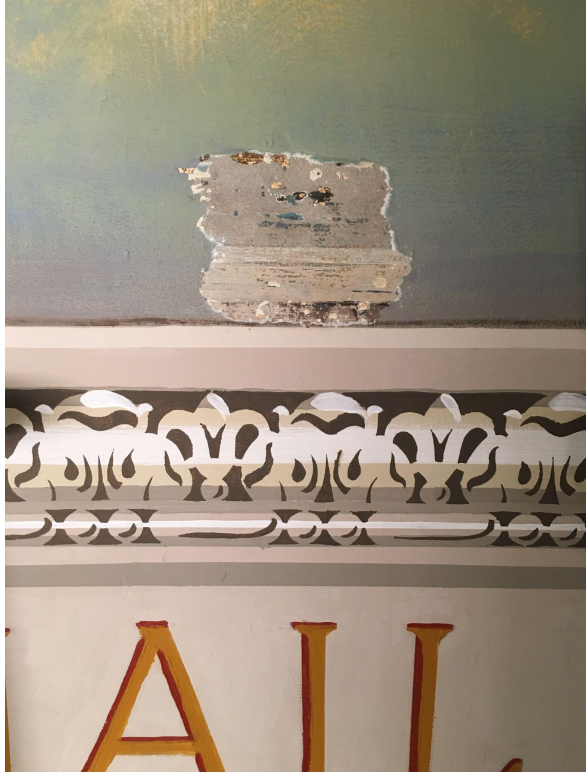
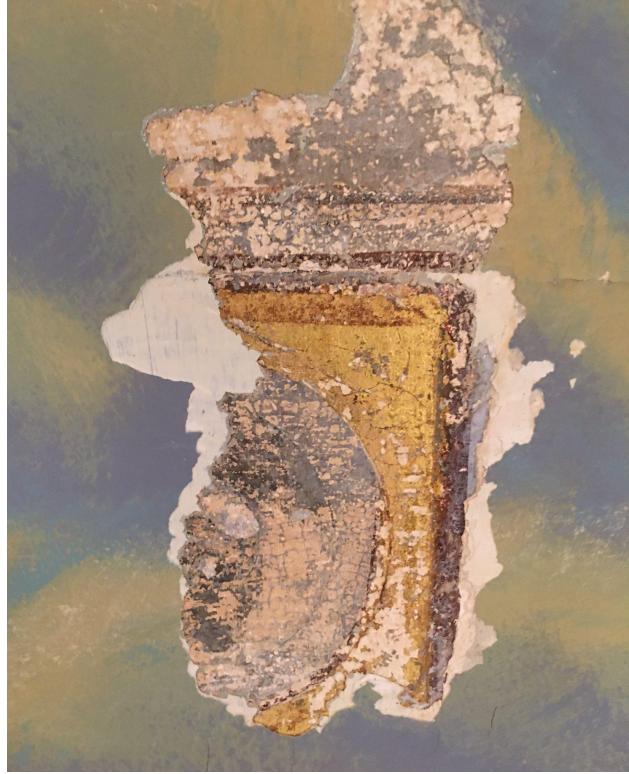
Cleaning tests using a mixture of organic solvents, a paint stripper and by mechanical action with a scalpel proved that any removal of the upper paint layer using these methods would be tedious and probably not successful. Several campaigns of overpaint on the original surface of the painting are noted with various shades of light to medium to dark blue present. An architectural type design was revealed under the overpaint along the border with the use of a gold/metal leaf present. The lowest layer of blue ceiling paint appears to be very dark in color similar to the Prussian Blue used in the Crucifixion painting below. It is the conservator's opinion that this dark blue color was the original layer of paint used in the original execution of the ceiling painting.

Details of Overpaint Removal & Architectural Design Exposed

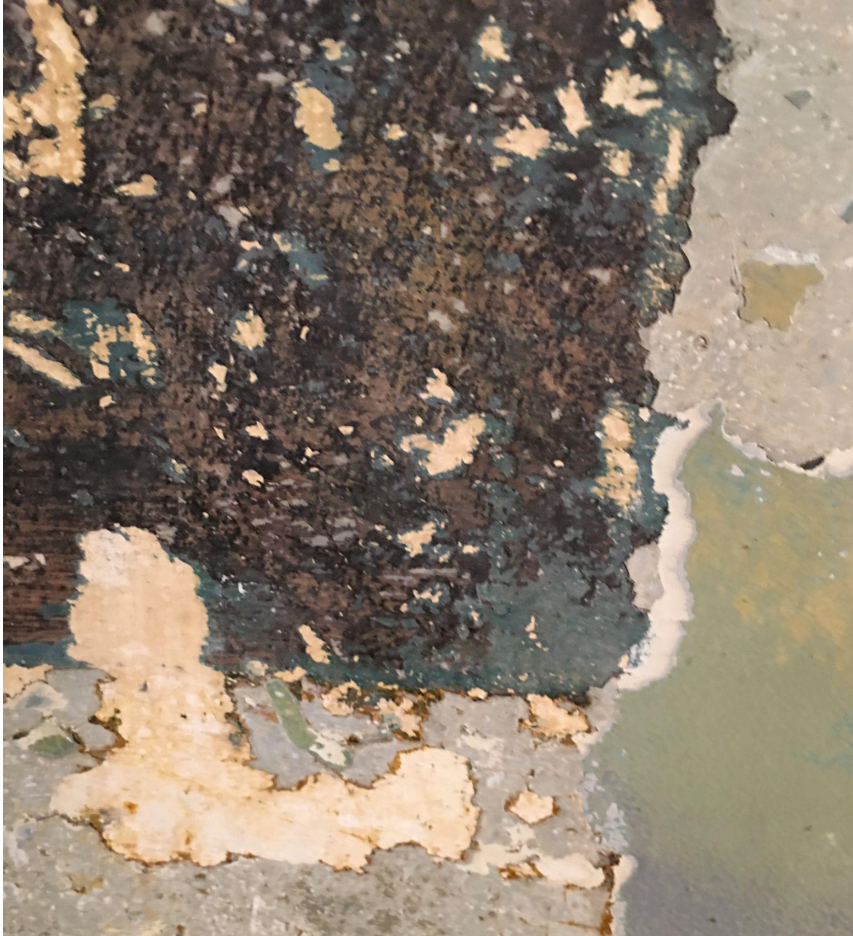
Detail of Overpaint Removal with Light, Medium and Dark Blue Colors Exposed

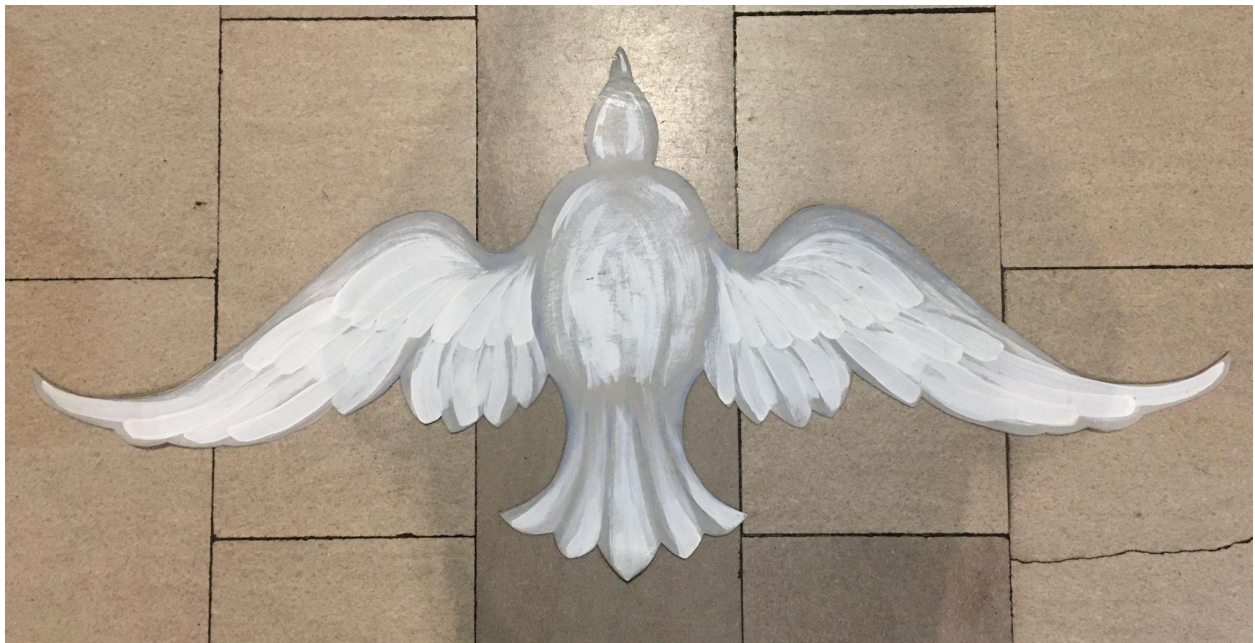
Previous Dove Painting painted on Canvas attached with adhesive
