ROGERS ART CONSERVATION, LLC
Catherine G. Rogers, Conservator of Paintings and Fine Art
62 Broad Street, Studio J1
Charleston, South Carolina 29401
catherinerogers@gmail.com
iPhone: 843-853-2953

CONSERVATION TREATMENT REPORT

Altar Painting - "Angel #4" by Cesare Porta
St. Mary's Catholic Church
95 Hasell Street
Charleston, South Carolina 29401

February 5, 2023

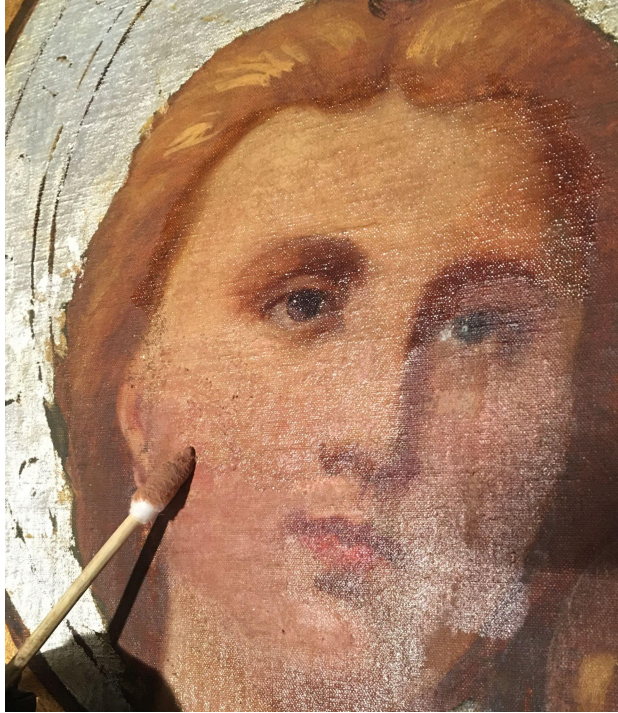
Overpaint removal in face

The grime and old varnish layers were removed with an organic solvent mixture of acetone and mineral spirits and aqueous cleaning solution (2% solution of Tri-ammonium citrate, buffered to pH 7.0). The tenacious oil overpaint was removed with a non-methylene chloride paint stripper and citric acid gel. In areas where the overpaint was difficult to remove, the stripper gel was covered with plastic wrap for an extended period of time to soften the overpaint. Areas of gel cleaning were cleared using a mixture of acetone and mineral spirits. Tacks were removed and any tack holes consolidated with Beva D-8 adhesive.

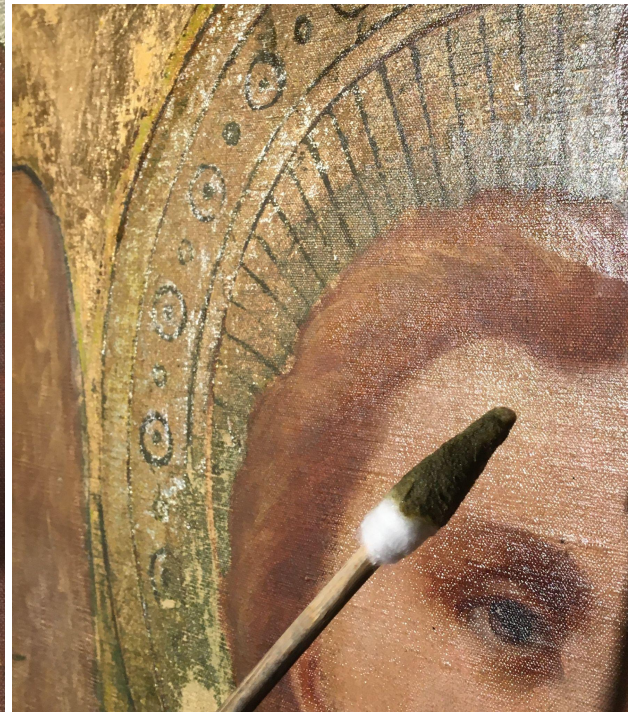
The halo around the Angel's head had been previously restored using a silver metallic leaf and the dark design details had also been altered from the original design. Cleaning tests in the halo revealed that the original halo was gold in color versus silver but a lighter gold color than the background.

Grime/overpaint removal in halo

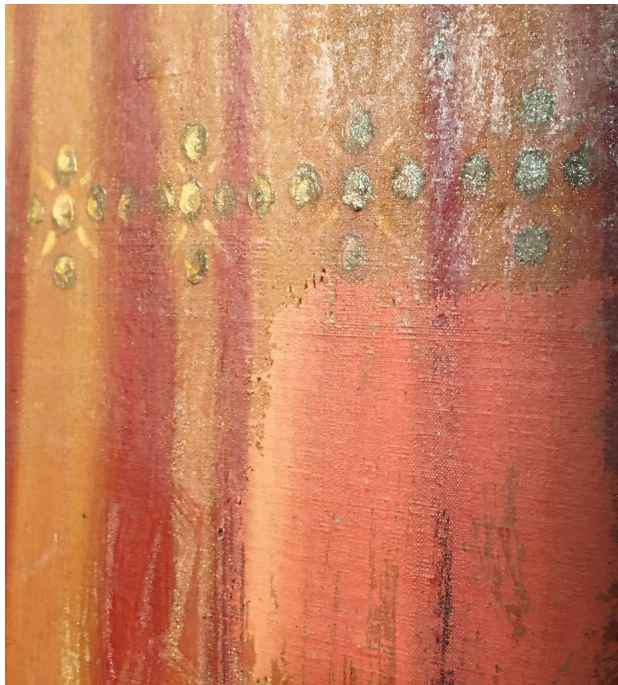
Varnish removal in robe

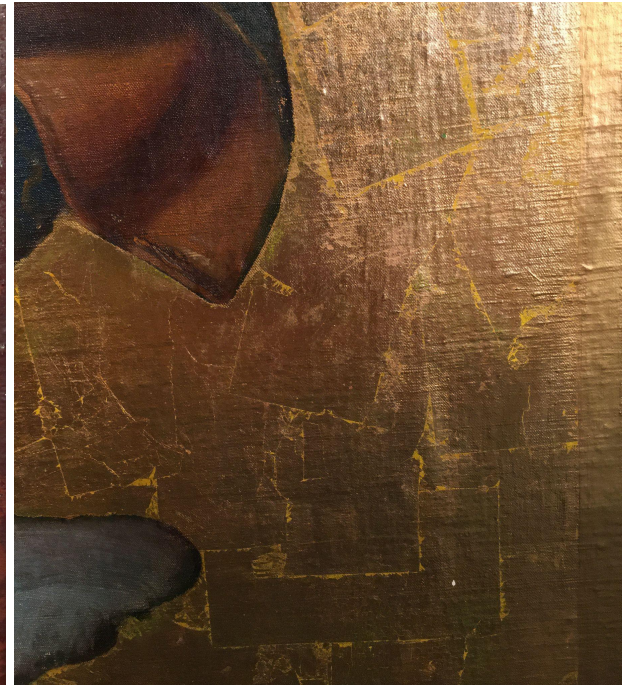
Area of metallic leaf application using remnants
