CONSERVATION TREATMENT REPORT

Altar Painting - "Crucifixion" by John S. Cogdell, 1814
St. Mary's Catholic Church
95 Hasell Street
Charleston, South Carolina 29401

January 31, 2023

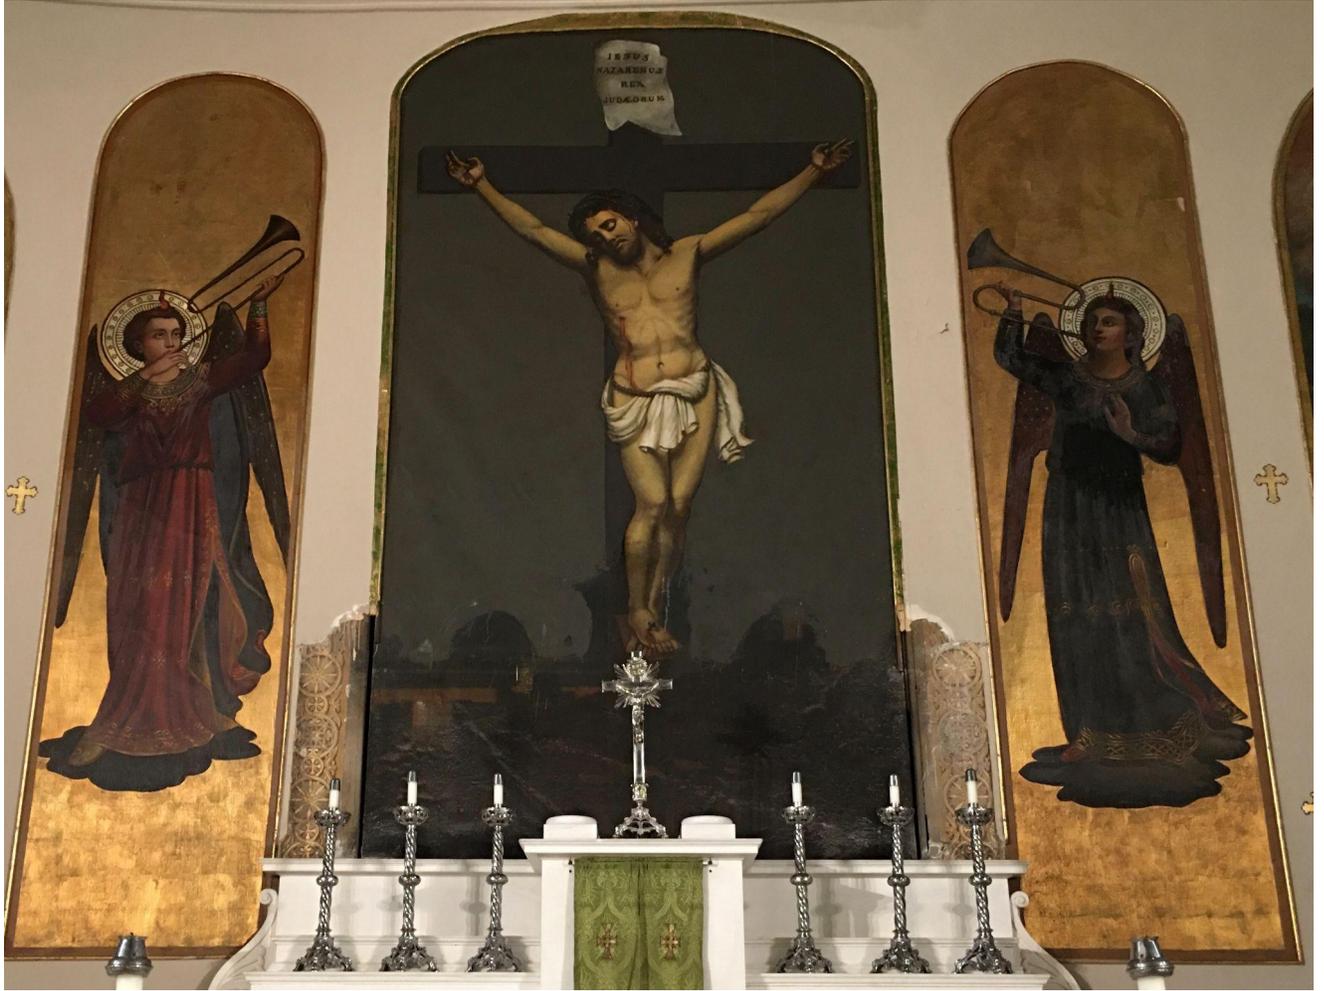
There are noticeable canvas distortions visible as canvas draws along the left edge of the painting. These are most likely due to a poor stretching of the canvas to its auxiliary support. Other canvas distortions are scattered throughout the design of the painting but are especially noted along the lower section which had been previously covered by the marble screen.

Before Treatment with Marble Screen removed.

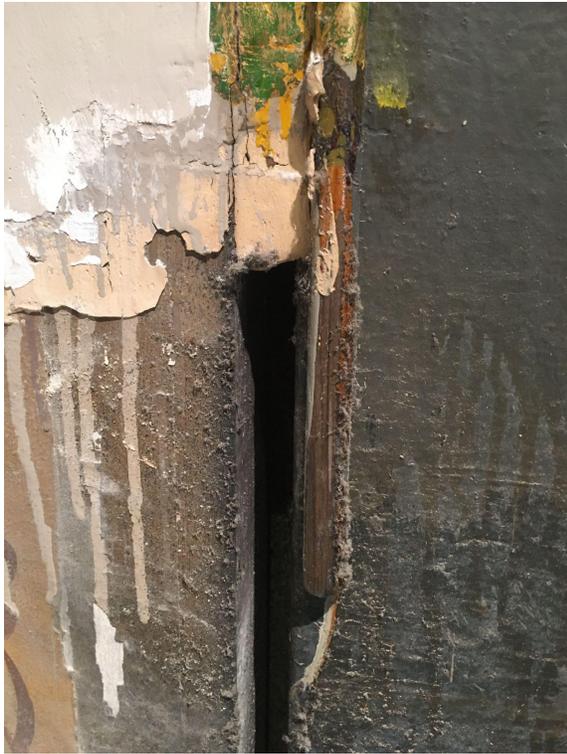
Gap between painting and plaster wall

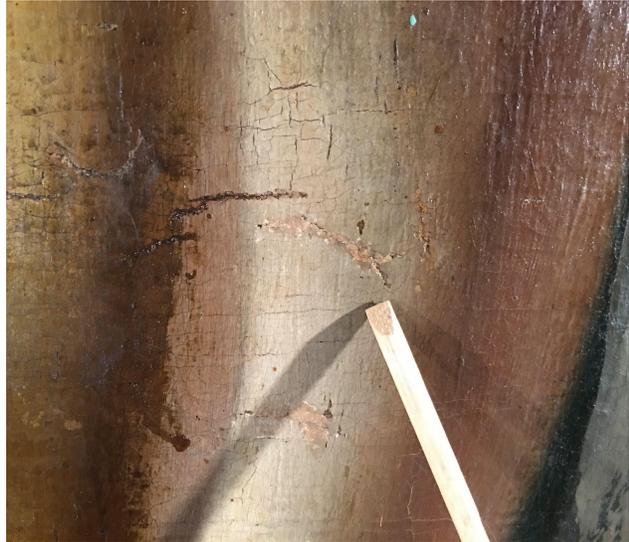
Detail of retouching which may be the artist's work

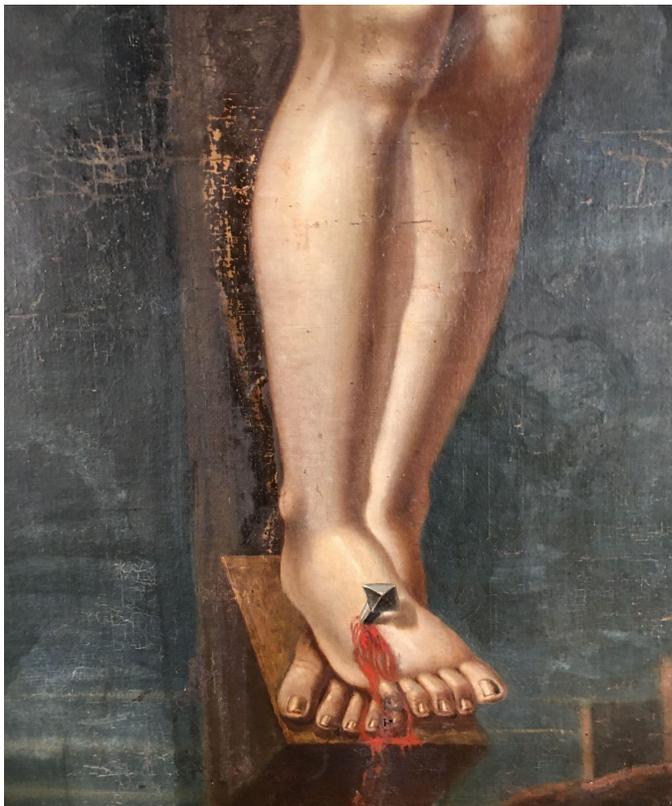
Detail of artist's change to position of proper right leg.

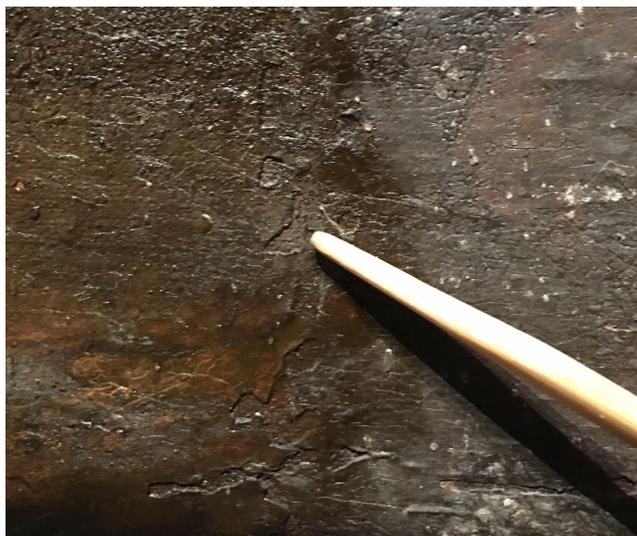
Area of missing ground and paint under overpaint.

Any loss of canvas in the old tears and paint layer losses were filled with a reversible vinyl fill material using a micro spatula, careful not to cover any of the original painting. In areas where the old fill was too high, the excess was removed mechanically with a scalpel. Any paint losses were toned with Winsor & Newton watercolors and inpainted with Gamblin Conservation Colors, pigments mixed with Aldehyde resin.

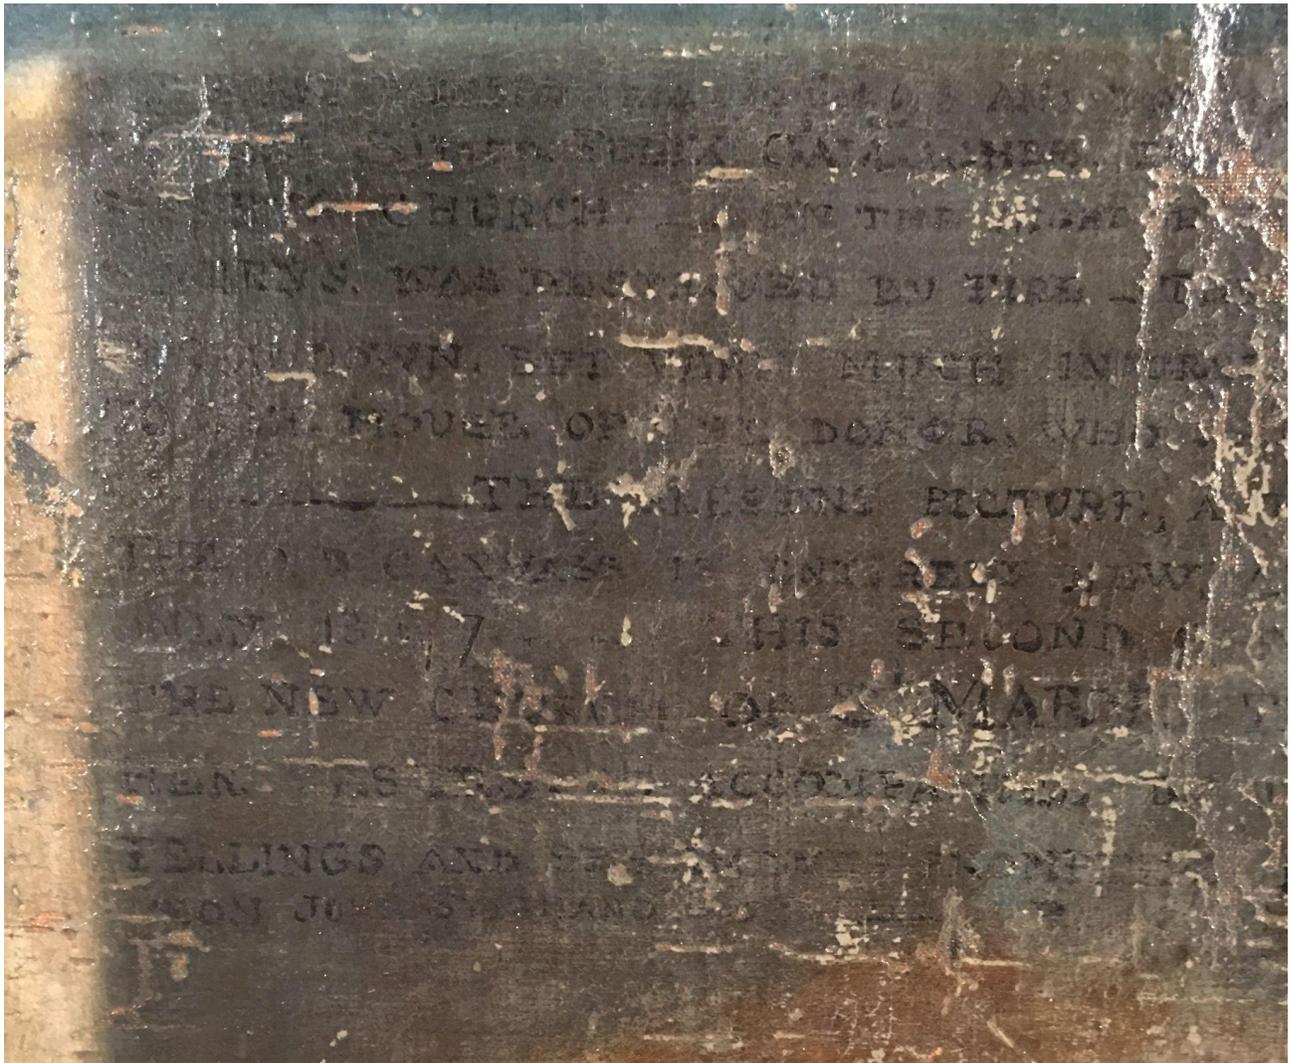
Under the previously overpainted areas, paint losses were noted in numerous, scattered areas of the painting, especially in the lower section of the canvas which had been covered by the marble screen. The painting appeared unsigned but a section of text was uncovered during the overpaint removal on the right section of the wall of Jerusalem and appears to be an explanation of the history of the painting and fire by John Cogdell.

During Treatment, Detail of Text on Wall of Jerusalem

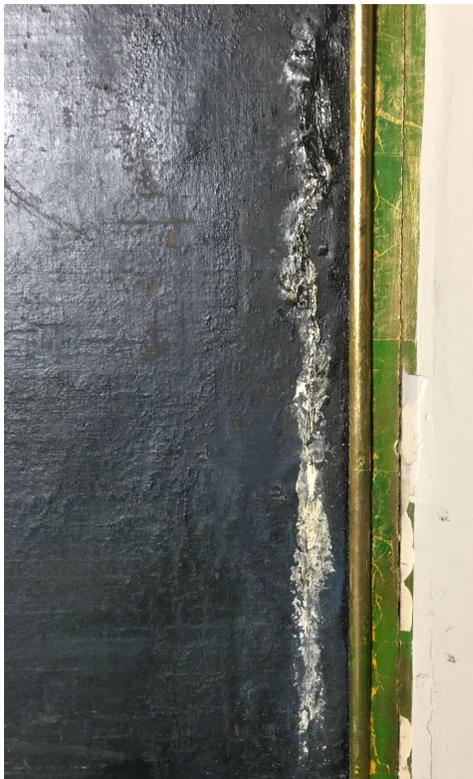
Detail of Old Tear

The two large tears and some smaller tears were treated with a heat set powder to act as an adhesive in securing the tear back together. The tear near the lower cross and the larger canvas distortions were relaxed with moisture and a local suction plate was used to reduce their distortions. Unfortunately this treatment provided success only temporarily as any reduction of canvas distortions was reversed with any increase of humidity levels in the church.

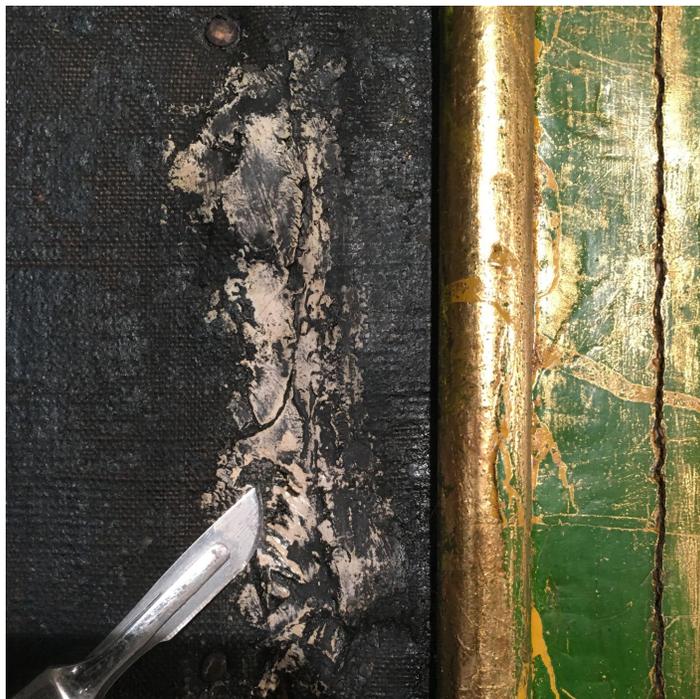
Detail of Fill material covering original paint.

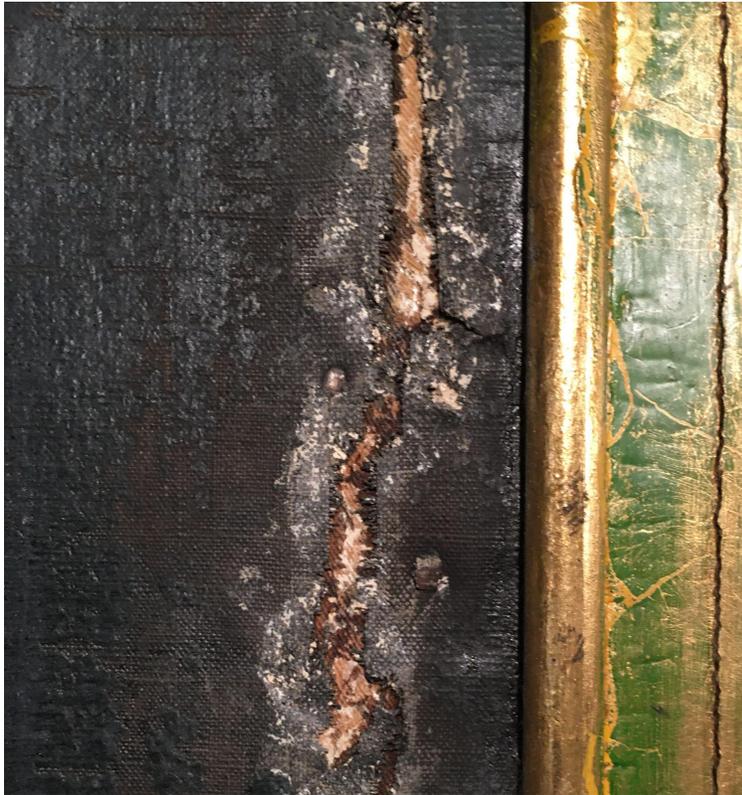
Tacks visible in the area of the old tear after fill material removed.

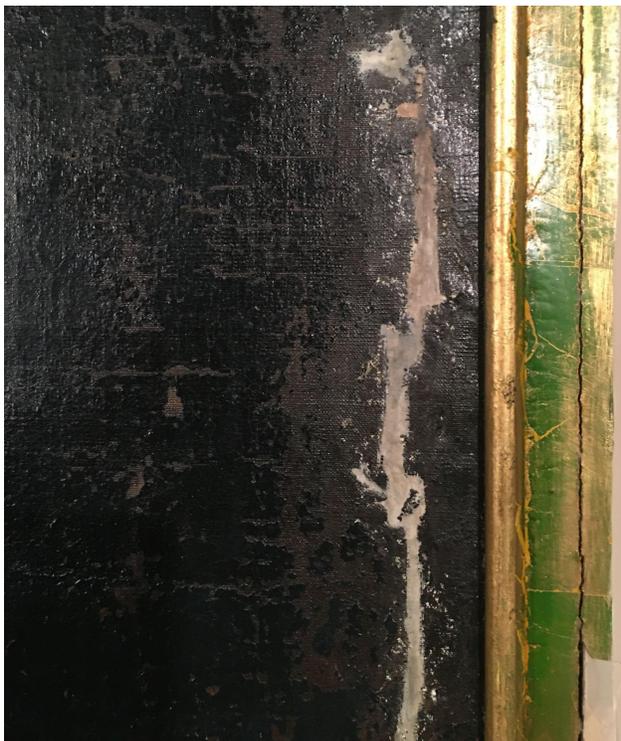
Areas of old loss filled in tear areas.
